**CONTROL OF LEAKAGE THROUGH JOINTS
IN CAST-STONE MASONRY AT
THE NATIONAL NAVAL MEDICAL CENTER**

**Progress Report No. 1
by
A. Hockman, E. J. McCamley and
E. W. Krussell**

**To
District Public Works Office
Potomac River Naval Command
Bureau of Yards & Docks
Department of the Navy**

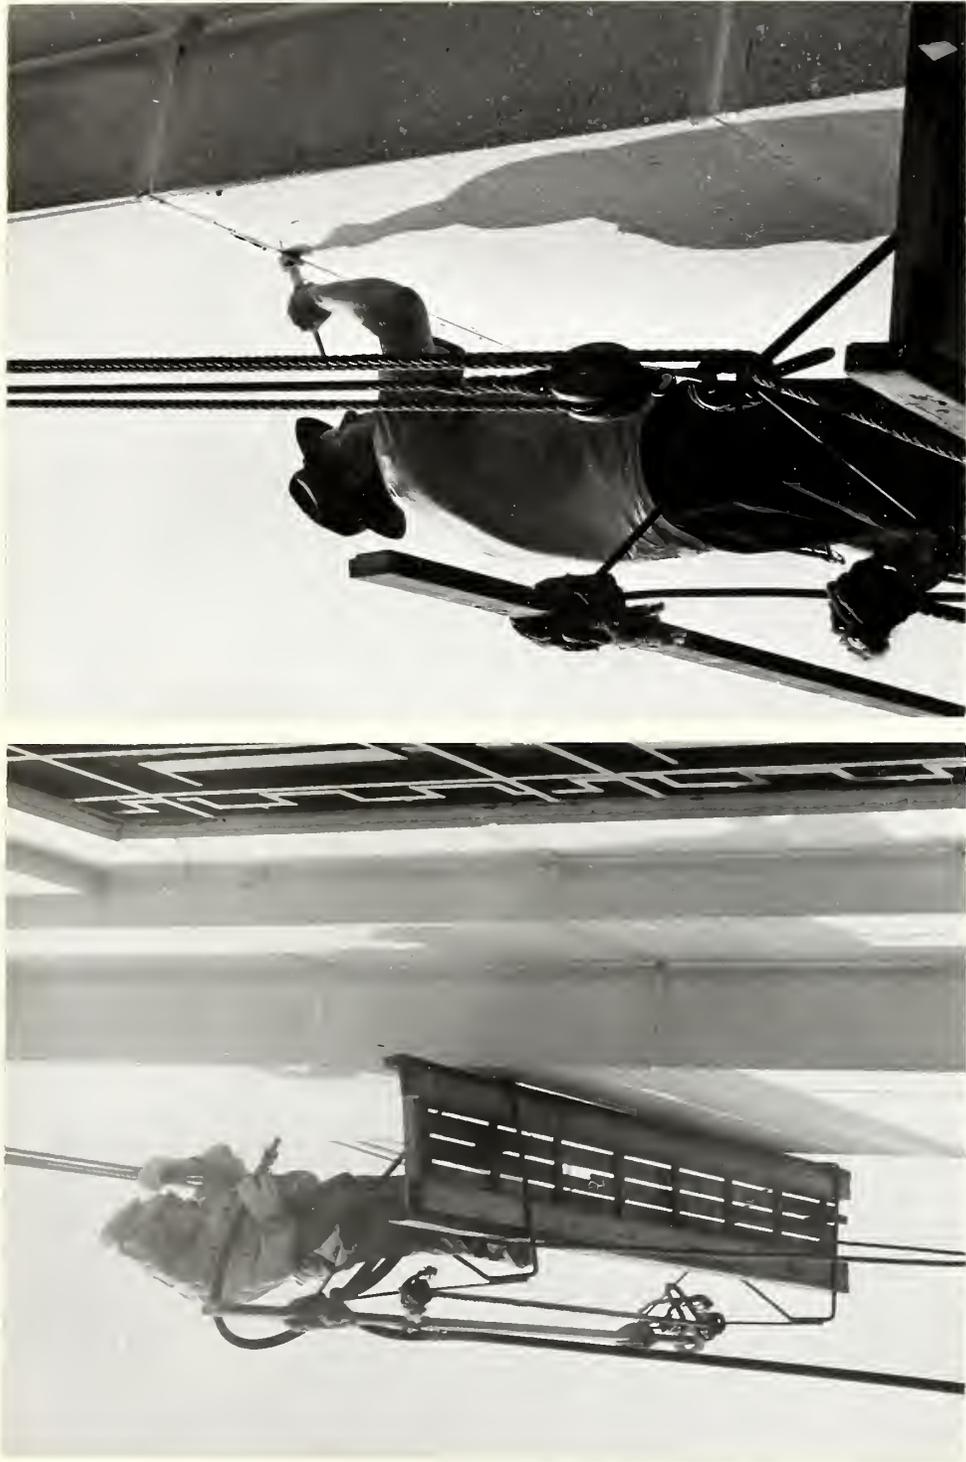
The contractor started the job by brushing the joints clean of dirt and dust which was followed by the application of 1 1/2 in. of masking tape to both sides of all joints. The joints were then sandblasted to remove old calking compound and dirt from the surface and sides of the joints, and at the same time exposing the faces of cracks between the panels and the mortar (see figure 1-A).

All loose mortar joints were raked out and filled with a mortar containing one part of white portland cement to 3 parts of silica sand, by volume, followed by tooling to a smooth concave surface. All other joints were grouted with a mixture containing equal parts of white portland cement and silica sand, by volume. The grout was applied in the form of a heavy cream using a special grouting brush (see figure 1-B). The fine cracks in some of the cast-stone panels were also grouted.

Fig. 1. Application of waterproofing to the mortar joints by contractor. (19th floor level, Building No. 1, Naval Medical Center).
(A) Sandblasting to remove old calking from surface of cast stone, and to expose cracks in joints.
(B) Applying the cement-sand grout to the joints.

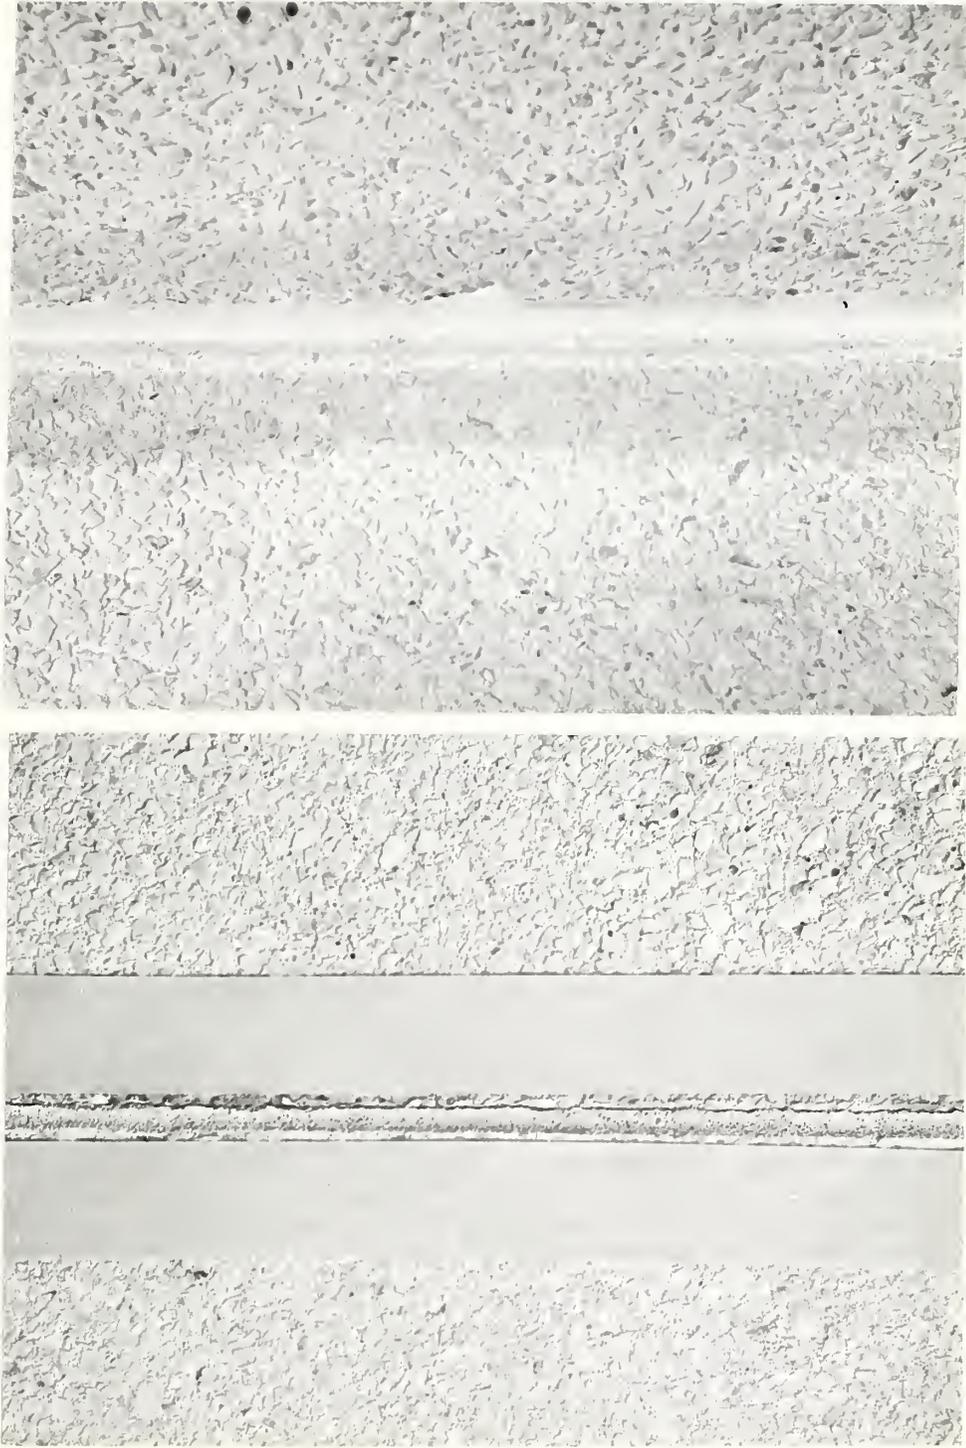
Examination of the masonry at the 19th floor level before the treatment was applied revealed that practically every vertical joint contained cracks. These cracks occurring primarily at the sides of the joints

varied in width from hairline to as much as one tenth of an inch; the latter occurring in some corners. Some of the cracks extended upwards continuously to the top of the building, while others only intermittently. There were a few instances of loose mortar in the vertical joints, the worst cases occurring in the corners. Many of the horizontal joints appeared in good condition up to the 10 ft. level. It was difficult to estimate the condition of the joints above this height. The cast-stone panels appeared to be in excellent condition with the exception of a few hairline cracks barely visible to the naked eye.

Fig. 2. Typical vertical joint as it appeared, (A) before the waterproofing treatment, (B) four days after the treatment.

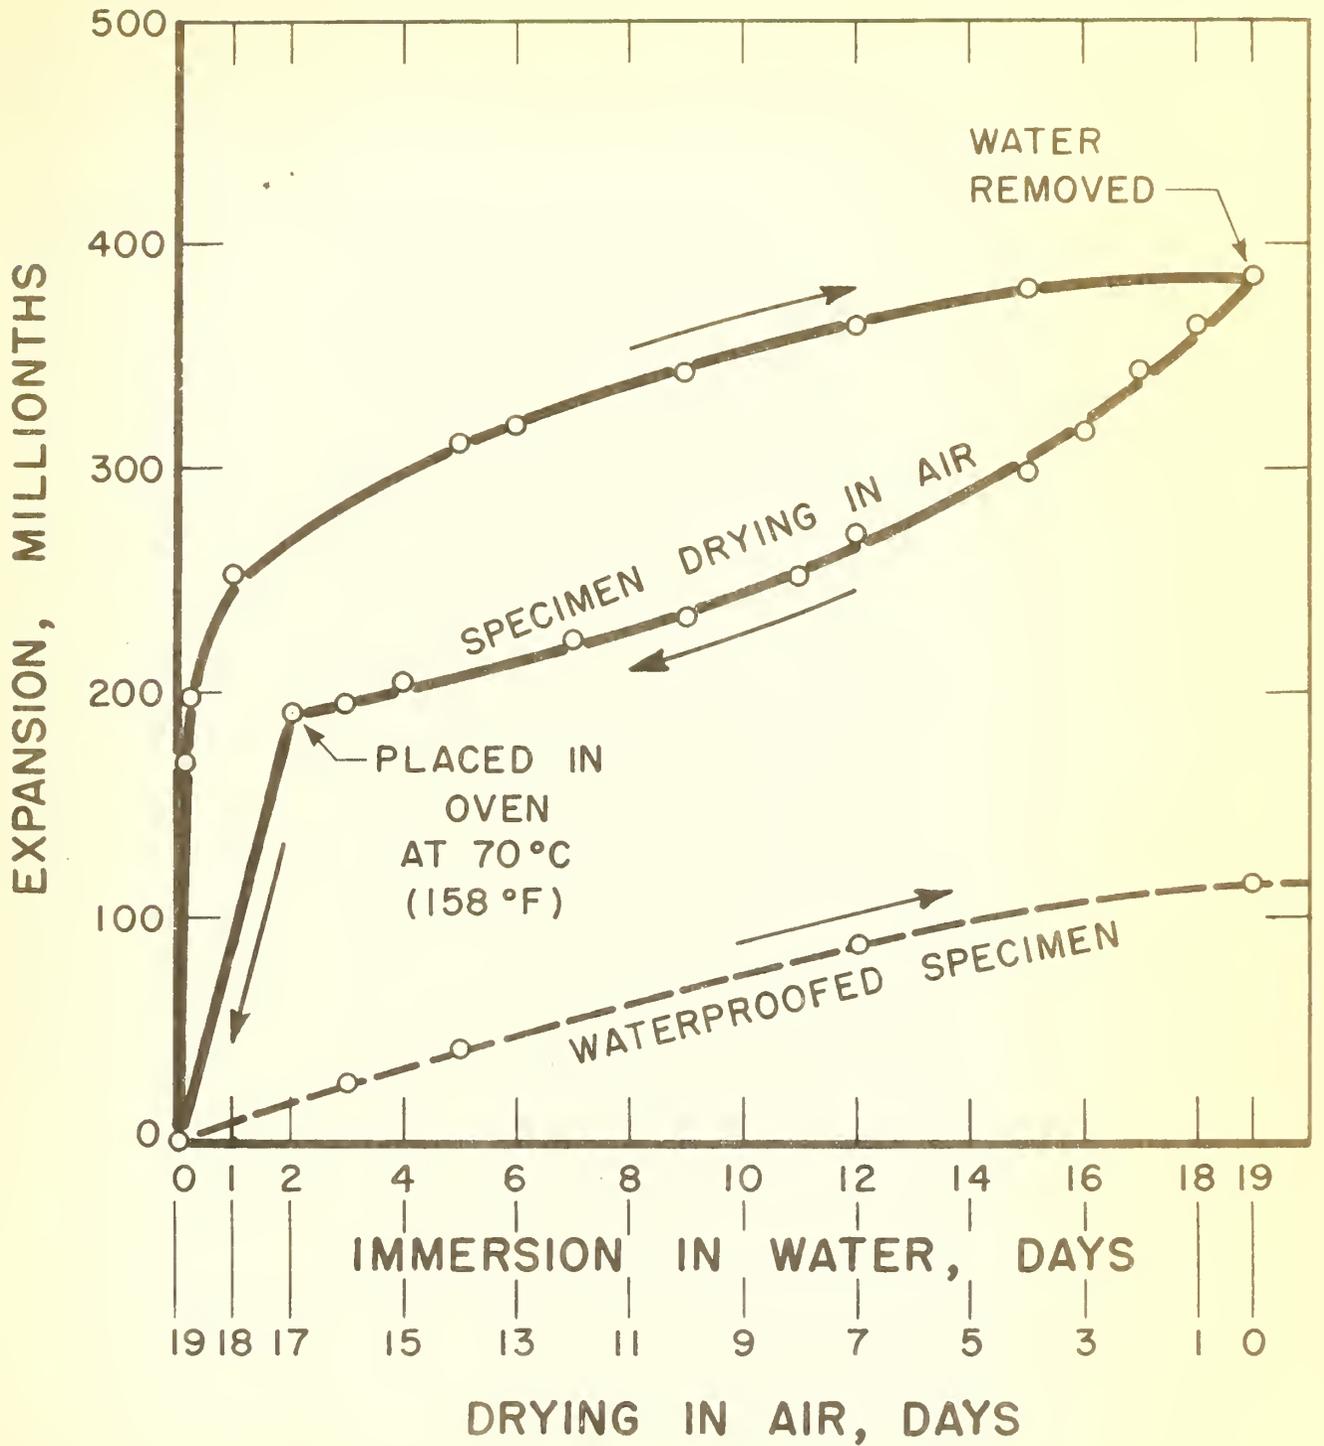
Figure 6 gives the moisture expansion and contraction curves for a sample of cast-stone originally used at the Naval Medical Center. After 19 days immersion in distilled water at constant temperature ($75^{\circ}\text{F} \pm 2^{\circ}$) the specimen expanded 385 microinches per in. or 0.0385 percent. The expansion curve rises sharply at the start of the test, attaining 15 percent of the total expansion after one hour and 66 percent after 24 hr. immersion. When the water was removed and the specimen allowed to dry, contraction proceeded at a comparatively slow rate. After 17 days of drying at room temperature, the specimen contracted to 50 percent of the amount it expanded when immersed. A heating of the specimen at 160°F for two days brought it back abruptly to its original length.

Figure 6, lower portion, shows the moisture expansion curve (dashed lines) of the waterproofed specimen of cast-stone. After 19 days of immersion, the sample expanded 115 microinches per in. or 0.0115 percent. Unlike that of the non-waterproofed specimen, the curve rises slowly and the expansion proceeds at a fairly uniform rate. Waterproofing of the cast-stone reduced the moisture expansion obtained on the non-waterproofed specimen by 92 percent for 24 hr. immersion and 70 percent for 19 days immersion.

FIGURE NO. 6 MOISTURE EXPANSION AND CONTRACTION CURVES (75°F) OF CAST STONE USED AT THE NAVAL MEDICAL CENTER.

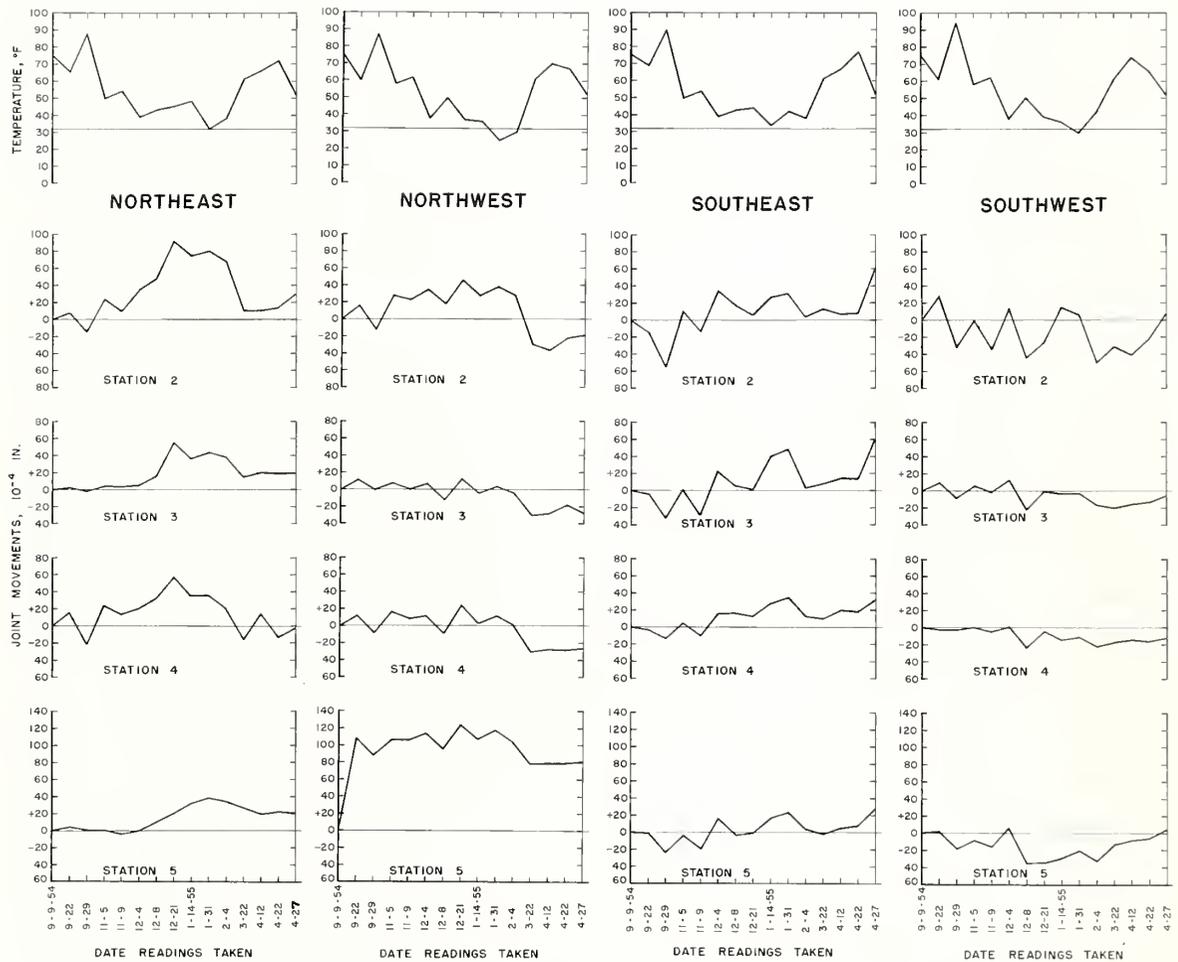
Figure 16 and table 3 give the complete record of joint movements as measured at all 16 gage stations on 15 separate occasions from September 9 to April 27, 1955. In general, the joint movements were directly related to the changes in temperature. A rise in temperature caused the cast-stone panels to expand which resulted in a closing or contraction of the joints. This is illustrated by the September 29 readings, when the temperature rose to 90°F and the joints contracted in most instances (cast-stone panels expanded). Similarly, a drop in temperature to 39°F on December 4, 1954, caused most of the joints to open or expand (cast-stone panels contracted). Figure 17 shows the correlation between the joint movements and the air temperature recorded at the time of gage readings.

Table 3 gives the maximum expansions and contractions of joints 2, 3, 4, and 5, on all four sides of the building, recorded from September 9, 1954, to April 27, 1955. During this period, the greatest change in temperature observed when measurements were made, was 64 F deg. (Weather Bureau records show a maximum change of 89 F deg.) The total movement in anyone joint ranged from a minimum of 0.0024 in. (1.0 percent of its initial width) as in joint No. 4, southwest, to a maximum of 0.0115 in. (4.6 percent) in joint No. 2, southeast. The average movement for all 16 joints was 0.0066 in. or 2.6 percent. The joints on the southwest side averaged the smallest movement, 0.0043 in., and the southeast side averaged the largest, 0.0083 inches.

Fig. 16. Complete record of joint movements measured at 16 gage stations on 4 elevations. (19th floor level, Building No. 1, Naval Medical Center). Corresponding air temperatures for each date that readings were taken are plotted along the top of the graph.

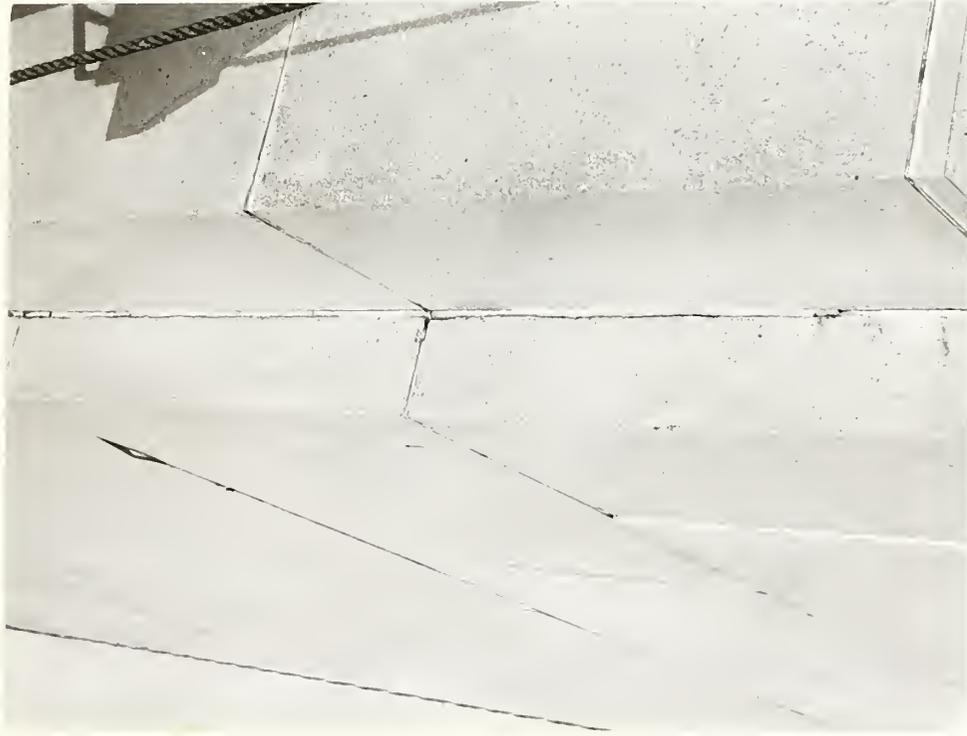
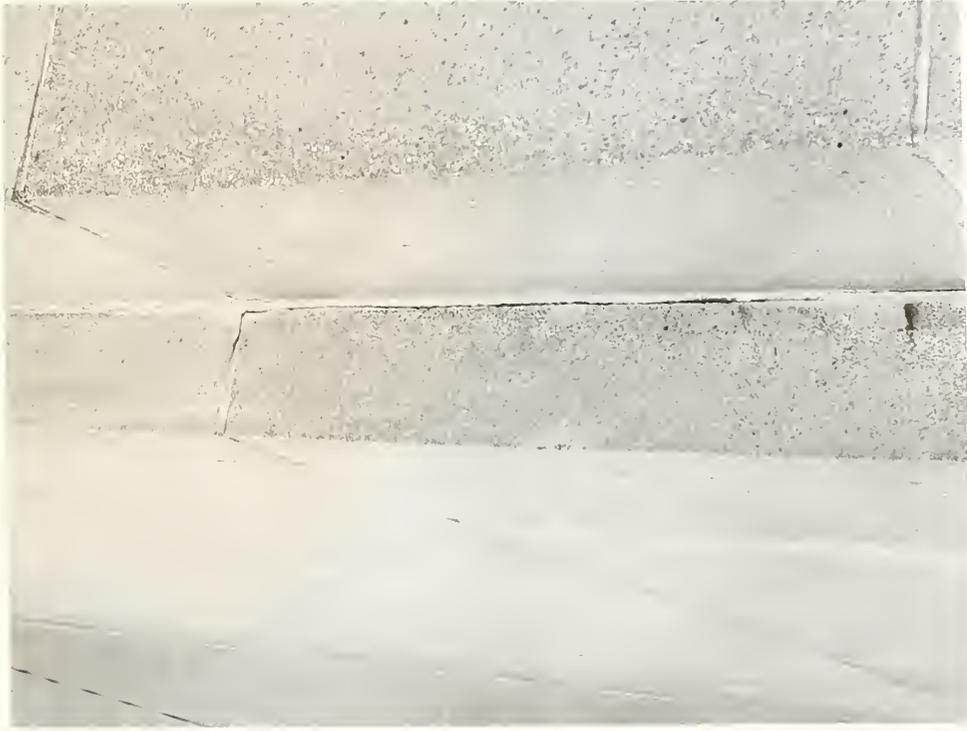
Although the authors have been informed by a representative of the maintenance department of the Medical Center that there has been no leakage of any consequence subsequent to the application of the waterproofing treatment, measurements made with the Whittemore gage indicated joint movements, which averaged 0.0066 in. for all four sides of the building, excluding the corner joints (chapter 5). Figure 18-A illustrates a corner joint (southeast) as it appeared the day before the waterproofing treatment was applied and figure 18-B shows the same corner as it appeared on April 22 approximately 7 months after the treatment.

Although cracks of various sizes are prevalent on all four sides of Building No. 1, 19th floor level, as indicated by inspection on April 22, they seem to be of insufficient size and number to allow leakage through the walls. It appears that the waterproofing treatment was instrumental in stopping the leakage that had occurred before the treatment was applied.

It might be noted here, that during the inspection of the joints on April 22, the senior author could, in many instances and with little effort, flake off, by means of a small knife blade, the thin coating of mortar from the side of a joint, and by so doing, reveal a crack that most likely existed before the grouting was applied. This indicates that, in many instances the cement grout did not penetrate into the opening of the joint, and was merely functioning as a thin shell-like coating over the existing crack.

Fig. 18. Illustration of a corner vertical joint on the southeast side, (19th floor, Building No. 1).
(A) Just before waterproofing treatment.
(B) As it appeared 7 months after treatment.
